Learn from the mistakes of others; you'll not live long enough to make them all yourself . . . **Issue 1/2005**

Beware of the 180° Turn Back to the Runway...

On September 7, 2002, a float-equipped Cessna 172P aircraft, with an instructor and student on board, departed from Lake St. John near Orillia, Ont. The purpose of the flight was to allow the student to practise takeoffs, landings, and simulated engine failures on departure. During the climb following the second takeoff, the instructor simulated an engine failure by pulling the throttle back to idle. The student executed a 180° degree turn as part of a simulated forced approach back to Lake St. John. During this simulated forced approach the aircraft stalled, pitched nose down and crashed into the swampy area along the shoreline. The aircraft came to rest in an inverted position with its nose embedded in the swamp. Fishermen on the lake were able to rescue both occupants from the partially-submerged aircraft. Neither the instructor nor the student was wearing a shoulder harness, and both received serious injuries. This synopsis is based on the Transportation Safety Board of Canada (TSB) Final Report A02O0287.

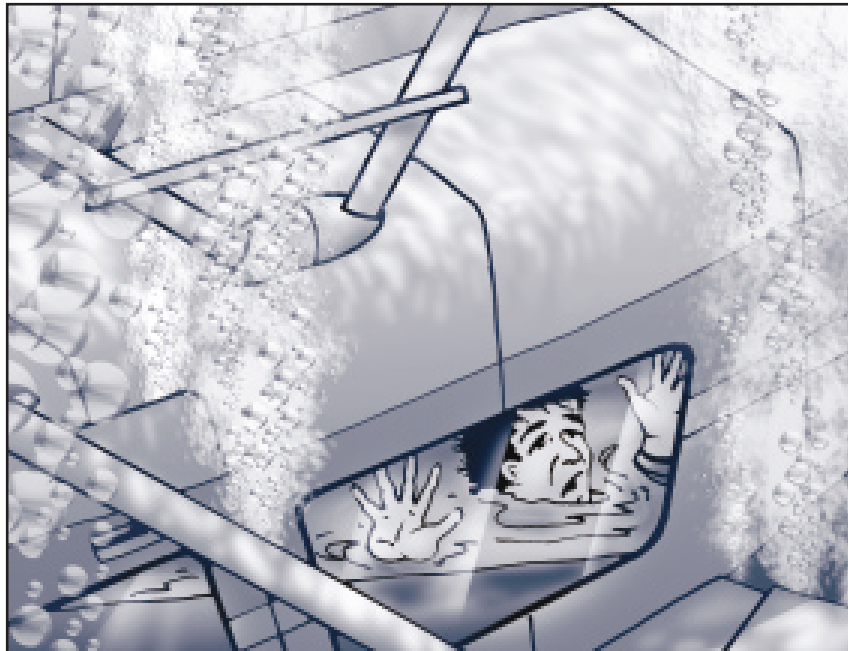
All occupants had been restrained with lap-belts, and the impact forces were well within the range of human survivability. Despite having received no immobilizing injuries, the survivors were unable to unlatch and open the cabin doors from the cockpit seats, which delayed their egress from the submerged and inverted aircraft. Post-accident examination determined that the cabin door handles were functional and appropriately placarded; however, impact damage to the airframe may

Dramatic visualization of a panic-stricken passenger facing a life-or-death underwater evacuation. True visibility would be much worse than illustrated.

have prevented the doors from opening, even if the door handles had been rotated to the unlocked positions. Egress actions by the victims were not determined, although both had released their seat belts.

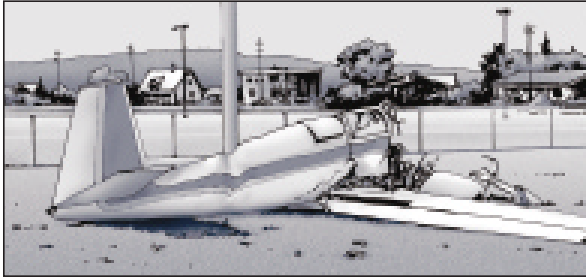
TSB Final Report A02Q0119—Engine Failure and Loss of Control

On September 2, 2002, a Mooney M20E was to make a flight according to visual flight rules (VFR) from Québec City to Rimouski, Que. The aircraft took off from Runway 30 at 13:46 Eastern Daylight Time (EDT), with the pilot, a flight instructor, and a passenger on board. As the aircraft was climbing through 600 ft above sea level (ASL), the control tower received a radio message from the aircraft, indicating that the engine had failed and an emergency landing would be made. The aircraft was observed in a steep right turn before nosing down and crashing near a baseball field, less than 1 NM north of the end of Runway 30. The aircraft was destroyed on impact but did not catch fire. The three occupants were fatally injured.

1. The pilot flying did not maintain the minimum flying speed after the engine stopped. The aircraft stalled at an altitude insufficient to allow the pilot to effect recovery.
2. The engine stopped when the aircraft was at low altitude, allowing little time for the pilot flying to select a suitable landing area, place the aircraft at the gliding flight speed, and complete the emergency checklist.
3. After the engine stopped, the pilot flying made a steep turn, thereby increasing the stall speed.
4. The reason for the engine's failure was not determined.

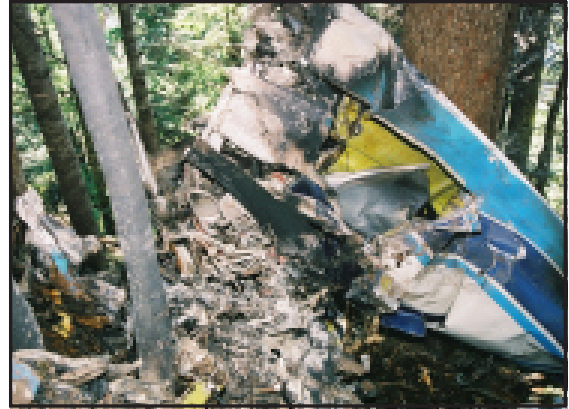
TSB Final Report A03P0133—Controlled Flight Into Terrain (CFIT)

On May 31, 2003, a Cessna 182 took off from a private airstrip near Chilliwack, B.C., with the pilot and four skydivers on board at approximately 18:40 Pacific Daylight Time (PDT). Two skydivers were released at 3 000 ft and two at 9 000 ft. The aircraft failed to return to the strip. No ELT signal was received. The Rescue Coordination Centre (RCC) at Victoria, B.C., was notified and a search was initiated. The aircraft was found six days later on a northwest-facing slope of the Skagit mountain range, 4 NM from the private airstrip, at an altitude of about 4 600 ft ASL. A fire had broken out on impact and consumed much of the cockpit area and left wing. The aircraft was destroyed. The pilot was fatally injured.

The armed ELT did not operate because of impact damage, hampering the search and rescue (SAR) operation.

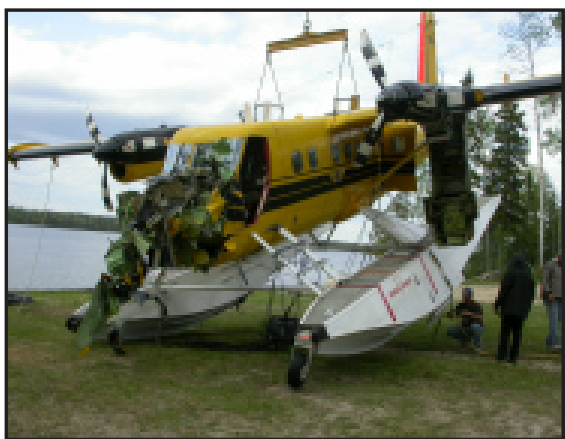
On June 5, 2003, a de Havilland DHC-6-300 amphibious aircraft with a single pilot on board was performing firefighting operations in the vicinity of Lake Wicksteed, approximately 10 NM north of Hornepayne, Ont. The aircraft was scooping water from Lake Wicksteed for the nearby fire. The lake is approximately 7 300 ft in length, with gentle rising terrain along its shoreline. This was the third scooping from the lake, and the approach was flown in an easterly direction in light wind conditions. The pilot performed the inbound checks, lowered the water probes to begin filling the float water tanks, and touched down on the lake. Within a short time, he observed water spraying from the overflow vents

located on top of the floats, indicating that the tanks were filled to capacity. He pressed a button on the yoke to retract the probes, and the aircraft immediately nosed over into the lake in a wings-level attitude and began to sink. The accident occurred at approximately 18:00 EDT. The pilot extricated himself from the aircraft and held on to the side of the partially submerged aircraft. A witness to the occurrence immediately boarded a powered aluminium boat and went to assist the pilot, while a second witness travelled to Hornepayne to notify the authorities and emergency services. Once the pilot reached the shore, he was taken to a nearby cottage where he remained until emergency services arrived. The aircraft came to rest on the bottom of the shallow lake, in an inverted attitude, with the floats above the surface of the water.

1. The operator's DHC-6 standard operating procedures (SOP) were not followed, and the vital action checklist was not fully completed during the approach. As a result, the bomb door armed switch on the centre panel was not selected OFF after the previous water bombing run, and prior to the scooping operation.

3. The hinged cover plate for the bomb door push button switch was not re-installed following maintenance to replace the push button switch. The push button was exposed, making an inadvertent selection more likely.

The operator has verified that every Twin Otter aircraft in their fleet is equipped with the cover plate over the bomb door push button switch. The operator will ensure that any future modifications to aircraft will be standardized to decrease the potential for inadvertent operation of systems.

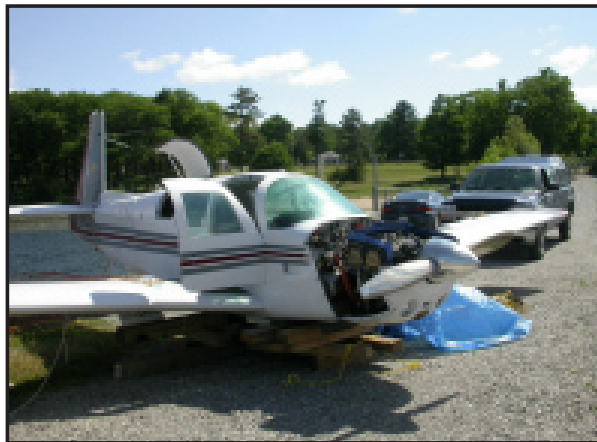
TSB Final Report A0300156—Engine Failure and Forced Landing on Water

On June 24, 2003, a Mooney M20E aircraft, with only the pilot on board, departed the Midland/Huron Airport, Ont., at 07:15 EDT, on a VFR flight to Charleston, West Virginia. A few minutes after takeoff, the pilot transmitted a distress call to Toronto Buttonville flight service station (FSS), reporting that the engine had lost power and he was diverting to Collingwood airport for an emergency landing. Shortly afterwards, he reported a total loss of engine power and his intention to ditch the aircraft in Georgian Bay. At 07:23 EDT, he reported his position to Toronto Buttonville FSS as 7.5 SM from Collingwood at 3 000 ft ASL, and indicated that the ELT was armed. This was the last radio transmission from the aircraft. The aircraft struck the water shortly thereafter. Two pilots flying in the vicinity heard the distress call. Both pilots volunteered to divert to the last position reported by the Mooney, but their search for the aircraft was unsuccessful. The RCC was notified, and at 09:12 EDT, located the aircraft submerged in 58 ft of water, 5 mi. west-southwest of Wasaga Beach, Ont. Divers were requested, and brought to the site by helicopter. The divers entered the water at 09:32 EDT and examined the aircraft, but could not locate the pilot. Once search and rescue (SAR) personnel departed the site, police divers took over the search for the pilot; his body was found at approximately 19:30 EDT.

1. Examination of the fuel servo revealed water contamination and corrosion in the fuel metering unit of the servo, resulting in reduced outlet fuel pressure to the fuel injectors. The engine quit as a result of the reduced fuel pressure, and the aircraft descended into the water.
2. The ELT did not transmit an emergency signal after it was selected to the ON position. The absence of a signal from the transmitter likely increased the time required by SAR personnel to locate the aircraft. △

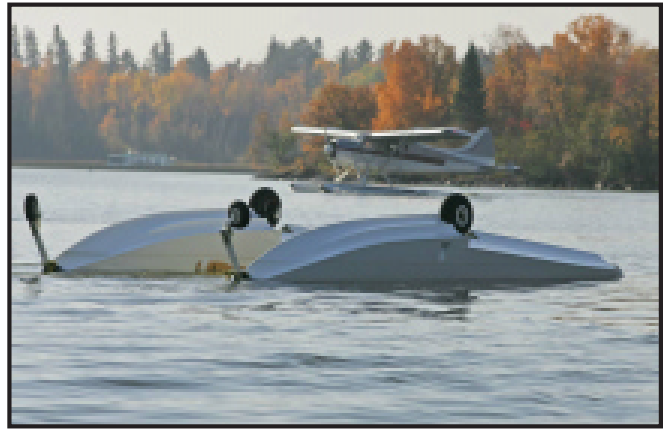
This amphibious float-equipped Cessna A185F was being flown a short distance between water bases. The pilot called the nearest flight information centre (FIC) to advise that the aircraft was on approach and would be landing at destination. The aircraft touched down with the amphibious wheels extended and the aircraft overturned on landing. The uninjured pilot was taken to hospital, examined and subsequently released.

Why did the pilot forget the wheels you ask? Could the short transit and rushed procedures have had anything to do with it? —Ed. △

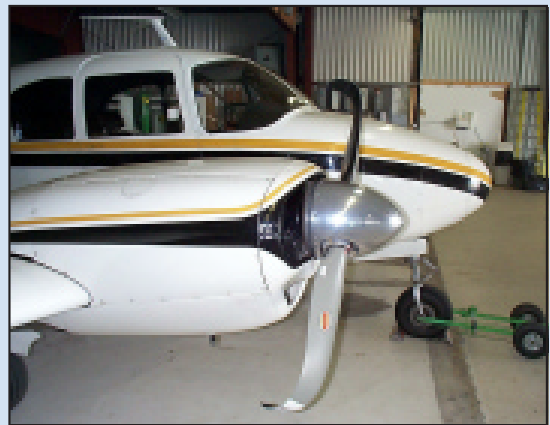
Here is a lesson that could have happened to any of us, and from which we can all learn. The pilot had just taken off in a Piper PA23-160 Apache from a long, paved runway, when he noticed that gasoline was leaking from the left wing fuel cap. The fuel tank cap had been improperly closed after refuelling or during the walk-around. The pilot assessed that there was enough runway remaining to land straight ahead, and he lowered some flaps and lowered the landing gear. Unfortunately, there was not enough time for the landing gear to complete the extension cycle and the aircraft landed on its belly. Both propellers were bent and the flaps were damaged. In this situation, a quick circuit and return to point of departure would have likely been enough to solve the problem. An open door or cargo door indication could lead to a similar situation. The golden rule of aviation always remains the same: *Aviate, Navigate, and Communicate.* △

Propellers are shown after the occurrence, damaged beyond repair.

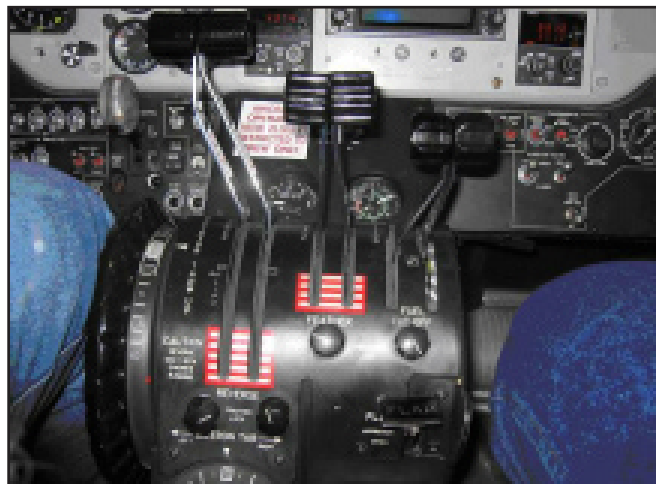
On June 3, 2004, during training exercises, the captain of a Beech 99 Airliner could not advance the power levers during a balked approach procedure. During the overshoot, the captain had called for power, gear and flaps up, but found that the power levers were stuck when an attempt was made to move them. The gear and flaps had been raised by the training pilot in the right seat, and with reduced power, the aircraft began to settle to the ground. The training pilot reached over to assist the captain, and pushed the power levers forward. The engines eventually spooled up and the overshoot was completed. Unbeknownst to the crew, the aircraft's belly pod had touched the runway prior to the overshoot. The belly pod damage was later discovered during a maintenance inspection.

Transport Canada (TC) reviewed this incident and is of the opinion that the throttles were operating normally, there was no "jam" and there was no aircraft defect or design problem. The design of the idle stop is such that the throttles may only be retarded into reverse after they are lifted and, conversely, that they will only move forward into positive thrust when they are in the lower position. In this case, when the pilot inadvertently pushed the throttles up, they did not move forward because they were blocked by the forward idle gate. This

behaviour of the throttle "system" is similar to that in all the King Air family of airplanes. The throttles were "blocked" by the gate but were not "jammed." In this case, the throttles operated as they were designed.

The operator checked its remaining fleet of Beech 99 and King Air A100 aircraft and found this condition can occur on all of them if the power levers are sufficiently raised. The operator has since included this awareness as part of its ground school training syllabus. It is not known what models of the Beech 99 and King Air aircraft that this anomaly extends to; however, jamming of the power levers in any model could result in serious consequences if immediate power is required and not available. The foregoing is provided for whatever follow-up action is deemed appropriate.
